# ATTACHMENT 8: 2017 Study

## General Mitchell International Airport 2017 Roof Survey & Budget Projections

December 2017

RE: Facility Inspection

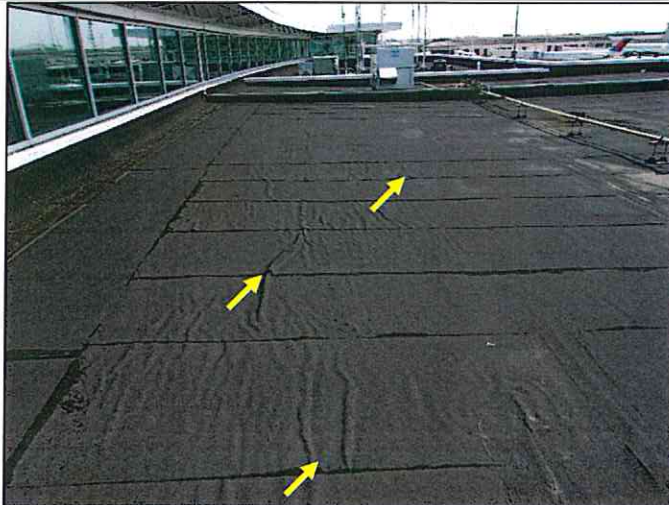
C-18

- Repair open fishmouths as needed.
- Excessive wrinkling.

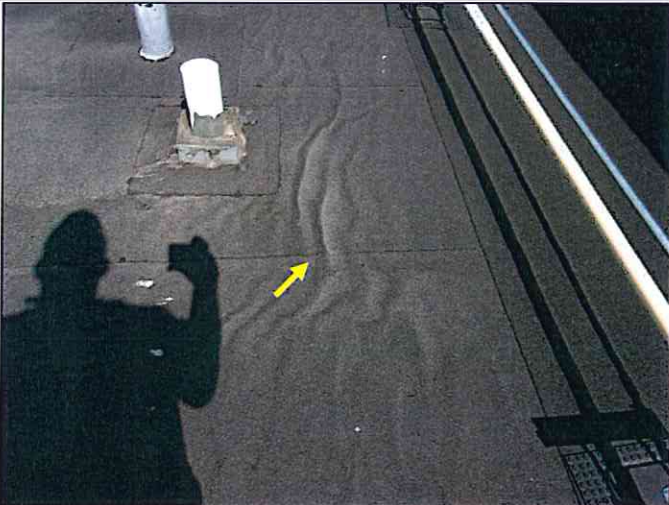
C-19

- Repair open fishmouths as needed.
- Excessive wrinkling.

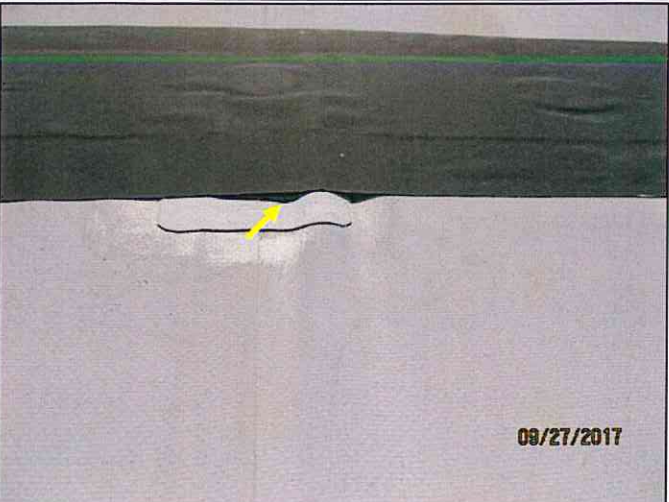
D-A

- Repair failing and lifted patches as needed.

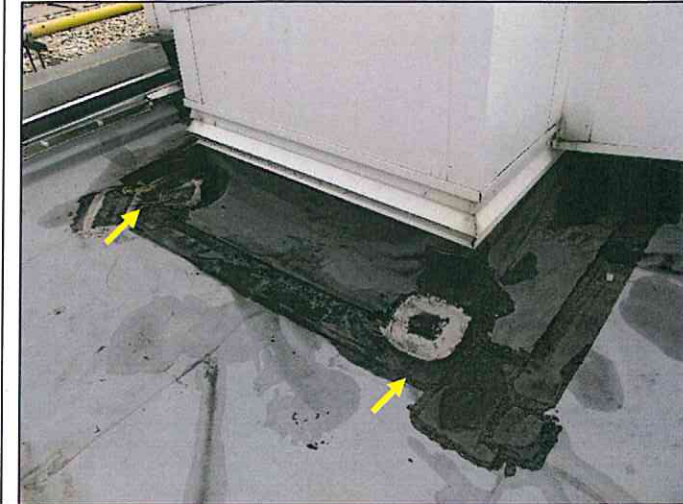
D-9

- Repair multiple failing patches.
- Roof is ready for replacement.

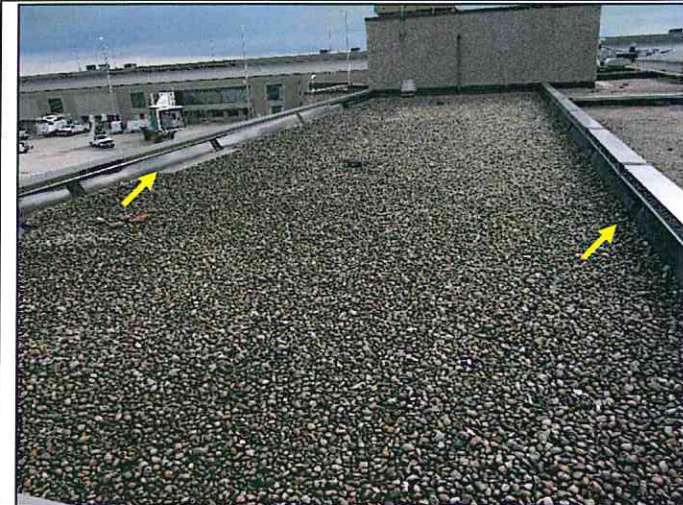
D-11

- Re-flash approximately 190' of wall flashing

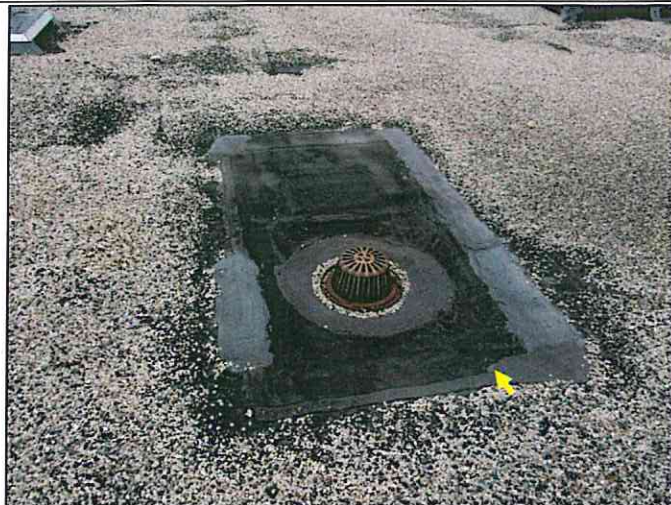
D-17

- Replace drain flashing.

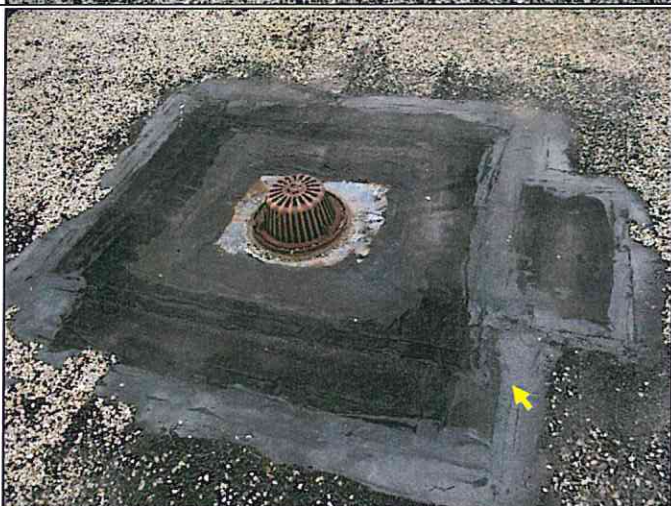
D-23

- Replace drain flashing.

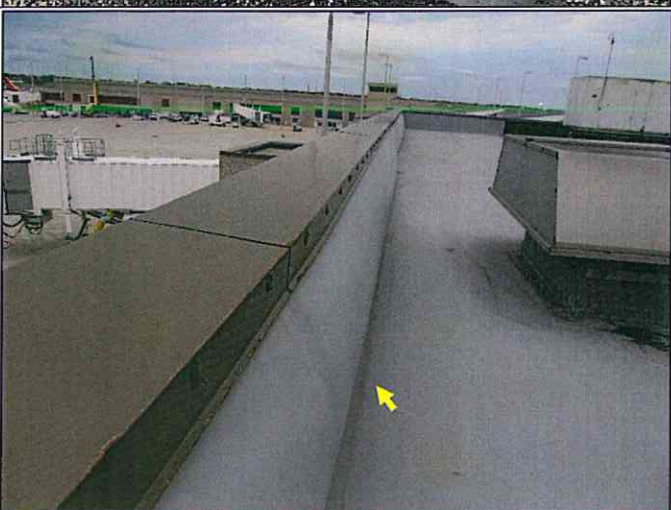
D-27

- Repair 90' of tented wall flashings.

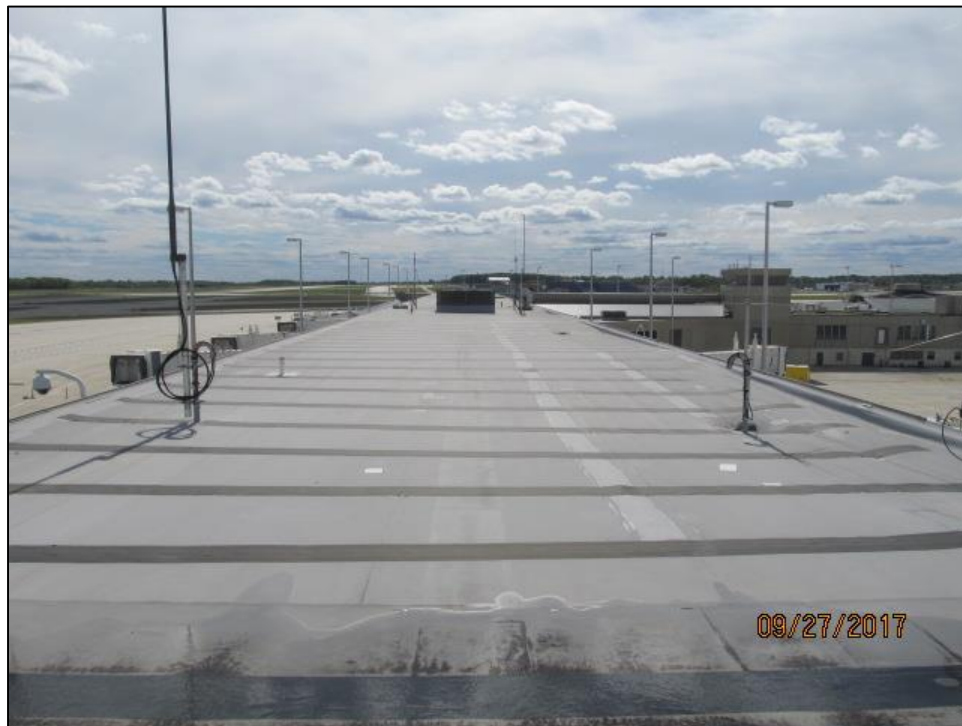
Roof Section	D-A
Estimated Age	24-29
Roof Area (SF)	27,850
Structural Deck	Metal
Drainage	Roof Drains
Vapor Retarder	-
Insulation	2" Phenolic Foam, 1" Perlite
R-Factor	15.28
Membrane	TPO-Mechanically Attached
Flashing	TPO
Surfacing	-
Estimated Roof Service Life	1-3 years
Replacement Cost	\$306,350
Annual Maintenance Budget	\$1,500

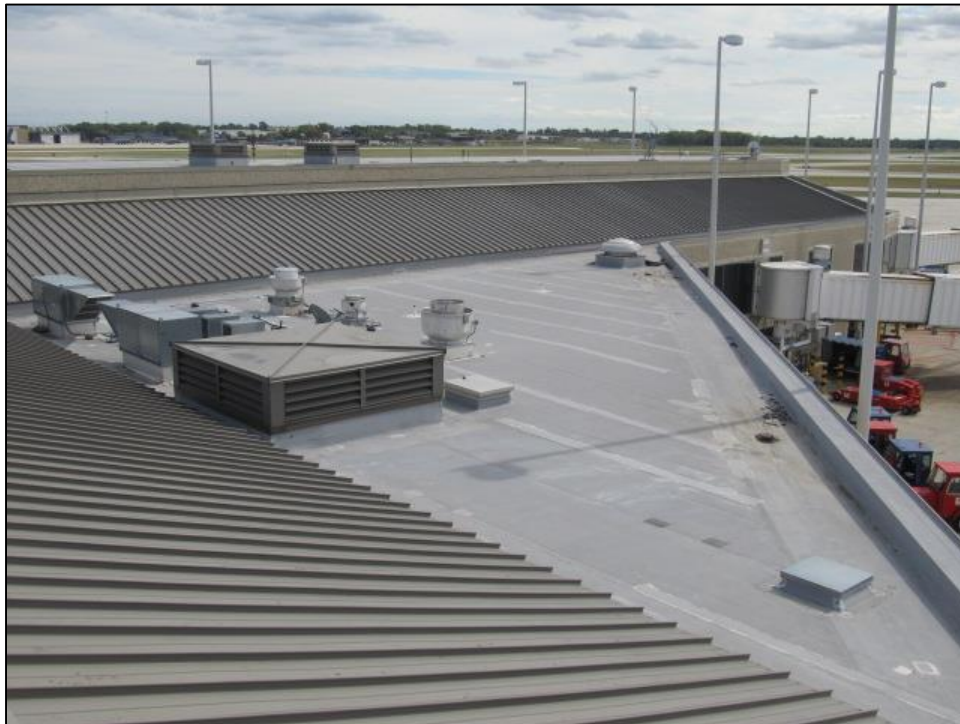
Roof Section	D-B
Estimated Age	24-29
Roof Area (SF)	5,244
Structural Deck	Metal
Drainage	Roof Drain
Vapor Retarder	-
Insulation	2 ½" Phenolic Foam, 1" Perlite
R-Factor	18.4
Membrane	TPO-Mechanically Attached
Flashing	TPO
Surfacing	-
Estimated Roof Service Life	1-3
Replacement Cost	\$57,640
Annual Maintenance Budget	\$750

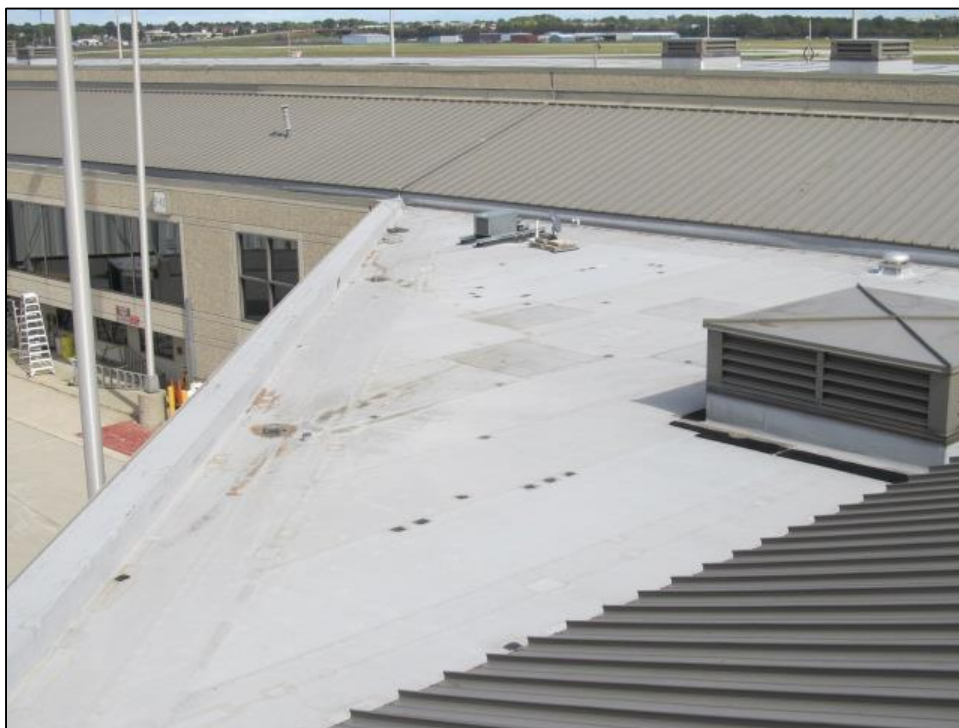
Roof Section	D-C
Estimated Age	24-29
Roof Area (SF)	3,350
Structural Deck	Metal
Drainage	Roof Drain
Vapor Retarder	-
Insulation	2.5" Phenolic Foam, 1" Perlite
R-Factor	18.4
Membrane	TPO-Mechanically Attached
Flashing	TPO
Surfacing	-
Estimated Roof Service Life	1-3
Replacement Cost	\$36,850
Annual Maintenance Budget	\$750

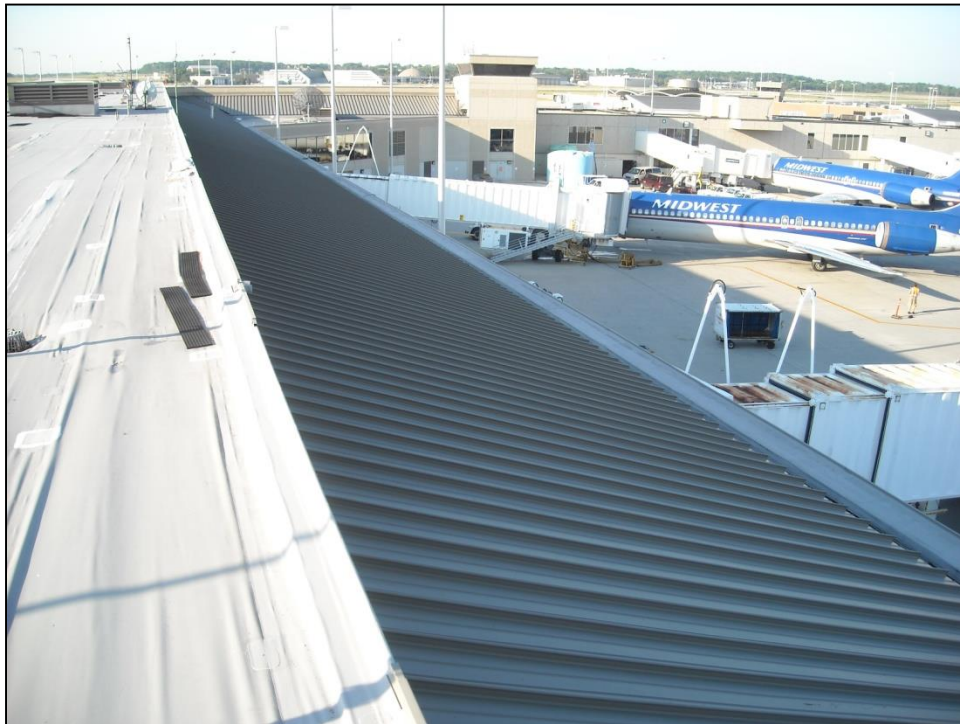
Roof Section	D-D
Estimated Age	24-29
Roof Area (SF)	31,200
Structural Deck	DNC
Drainage	Perimeter Gutter
Vapor Retarder	DNC
Insulation	DNC
R-Factor	DNC
Membrane	Metal Panels
Flashing	Metal
Surfacing	-
Estimated Roof Service Life	10+
Replacement Cost	\$358,800
Annual Maintenance Budget	\$750

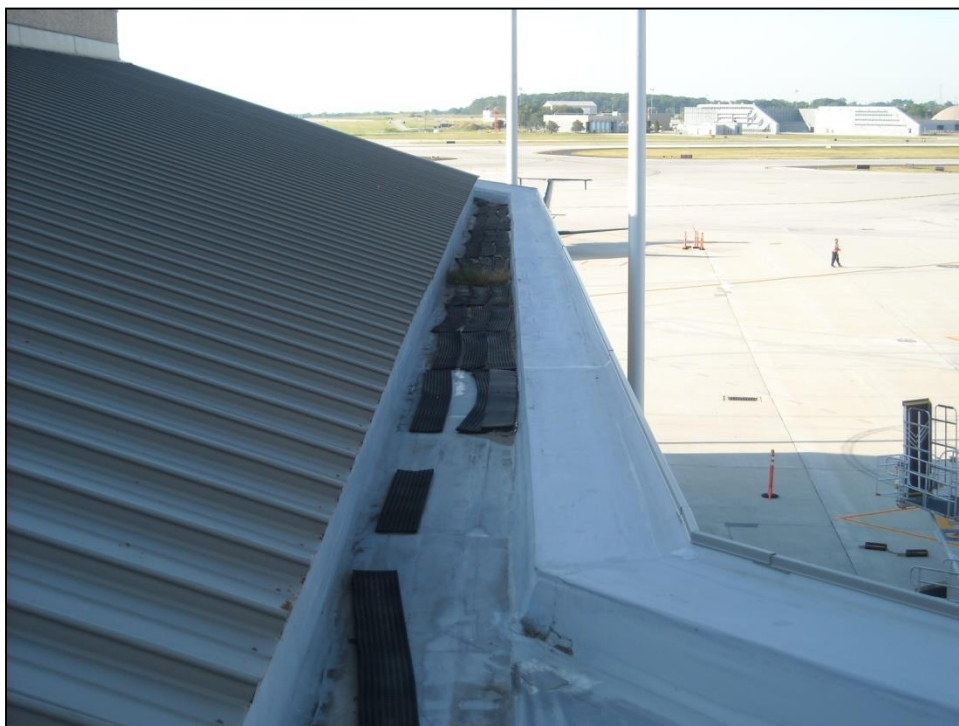
Roof Section	D-E
Estimated Age	24-29
Roof Area (SF)	2,280
Structural Deck	Metal
Drainage	Roof Drains
Vapor Retarder	-
Insulation	Tapered Perlite, 2" Phenolic Foam, Dens Deck
R-Factor	Varies
Membrane	TPO-Mechanically Attached
Flashing	TPO
Surfacing	-
Estimated Roof Service Life	1-3
Replacement Cost	\$60,000
Annual Maintenance Budget	\$1,000

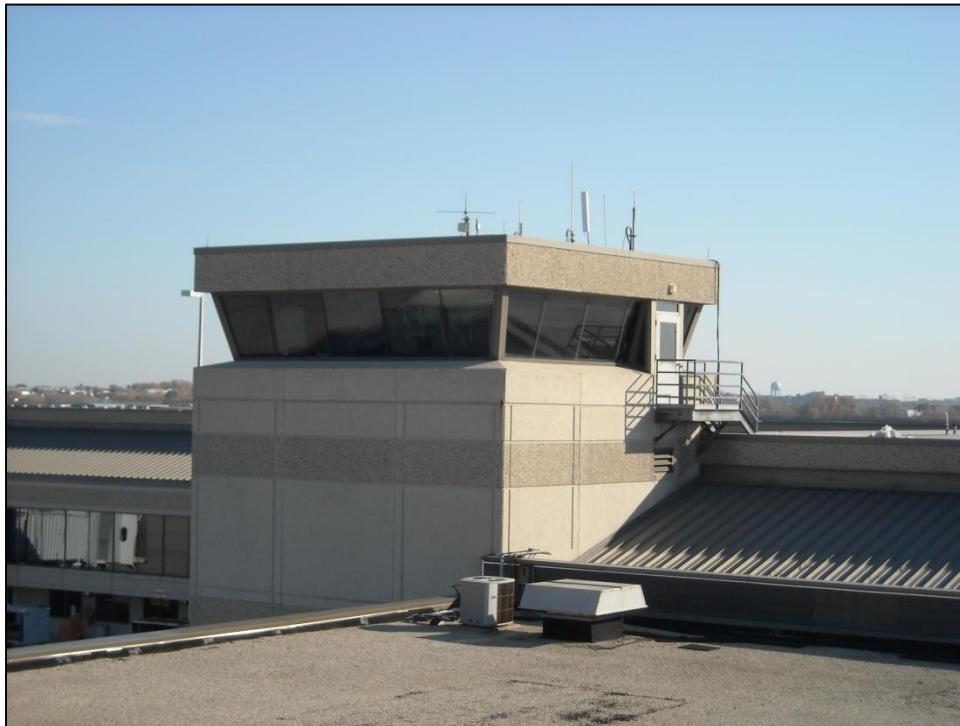
Roof Section	D-0
Estimated Age	24-29
Roof Area (SF)	700
Structural Deck	Metal
Drainage	Roof Drain
Vapor Retarder	-
Insulation	2" Phenolic Foam, 1" Perlite
R-Factor	15.28
Membrane	TPO-Mechanically Attached
Flashing	TPO
Surfacing	-
Estimated Roof Service Life	1-3
Replacement Cost	\$8,000
Annual Maintenance Budget	\$500

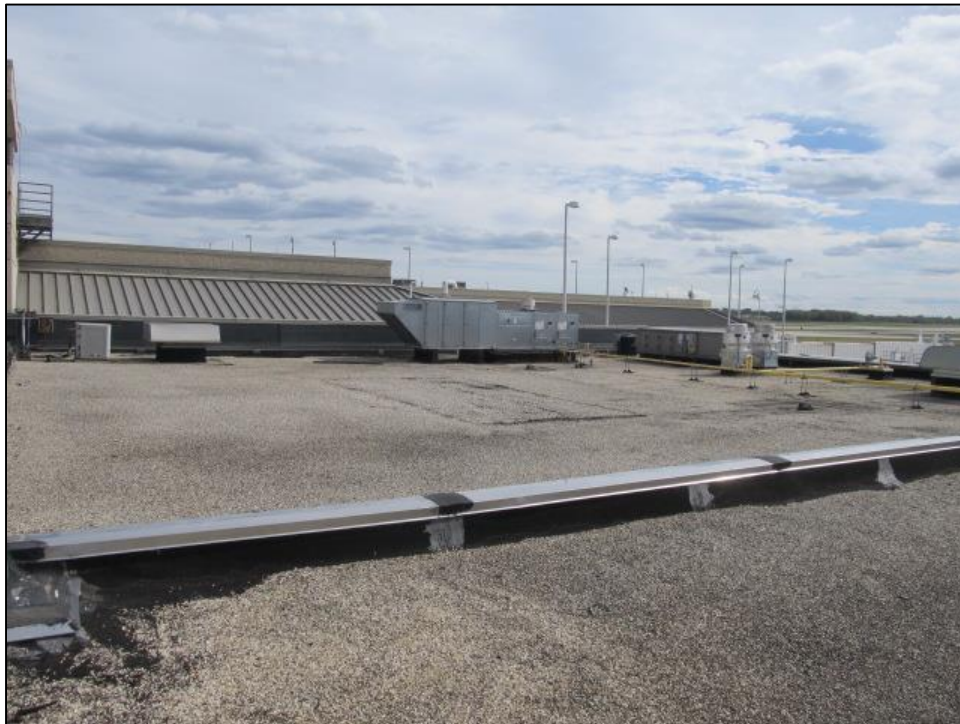
Roof Section	D-1
Estimated Age	24-29
Roof Area (SF)	4,150
Structural Deck	Concrete
Drainage	Roof Drains
Vapor Retarder	-
Insulation	Asphaltic Fill, 2" Perlite
R-Factor	
Membrane	Built-Up
Flashing	Smooth Surfaced Modified
Surfacing	Gravel
Estimated Roof Service Life	1-3
Replacement Cost	\$45,650
Annual Maintenance Budget	\$1,000

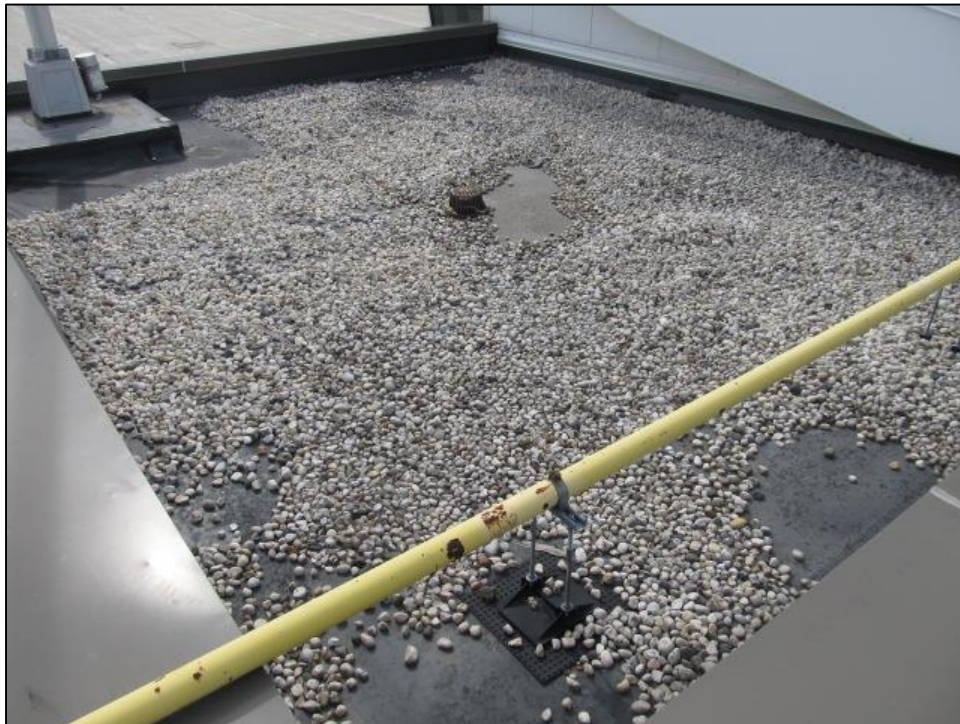
Roof Section	D-2
Estimated Age	12-14
Roof Area (SF)	480
Structural Deck	Concrete
Drainage	Roof Drain
Vapor Retarder	-
Insulation	3.5" Polyiso
R-Factor	19.25
Membrane	EPDM-Ballasted
Flashing	EPDM
Surfacing	Ballast
Estimated Roof Service Life	10+
Replacement Cost	\$5,280
Annual Maintenance Budget	\$200

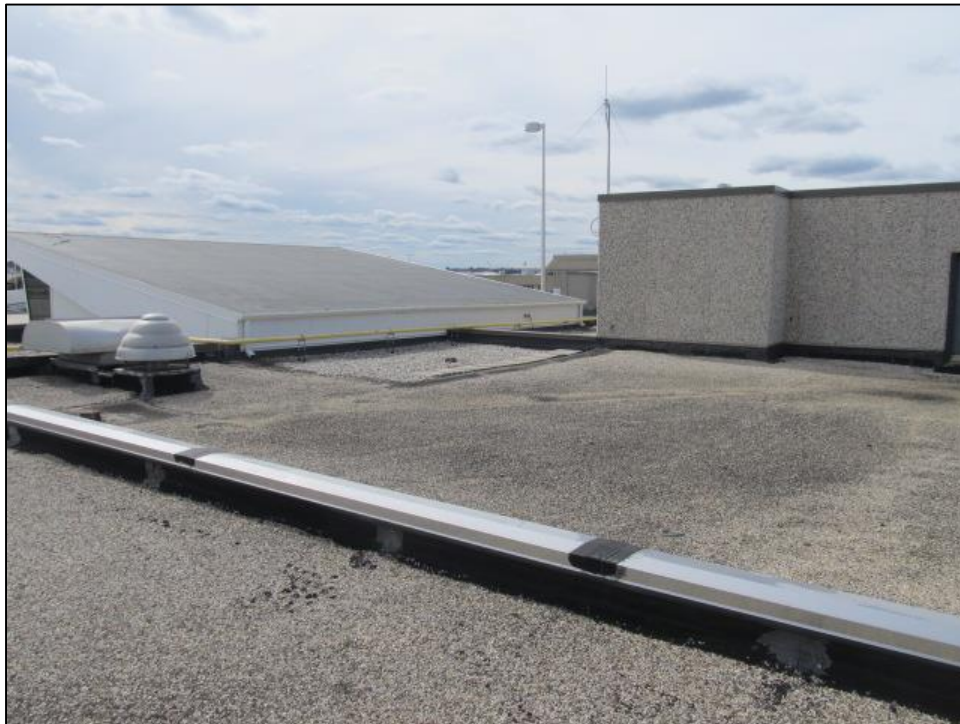
Roof Section	D-3
Estimated Age	24-29
Roof Area (SF)	1,535
Structural Deck	Concrete
Drainage	Roof Drain
Vapor Retarder	Yes
Insulation	2" Asphaltic Fill, 2" Perlite
R-Factor	
Membrane	Built-Up
Flashing	Smooth Surfaced Modified
Surfacing	Gravel
Estimated Roof Service Life	1-3
Replacement Cost	\$17,500
Annual Maintenance Budget	\$1,000

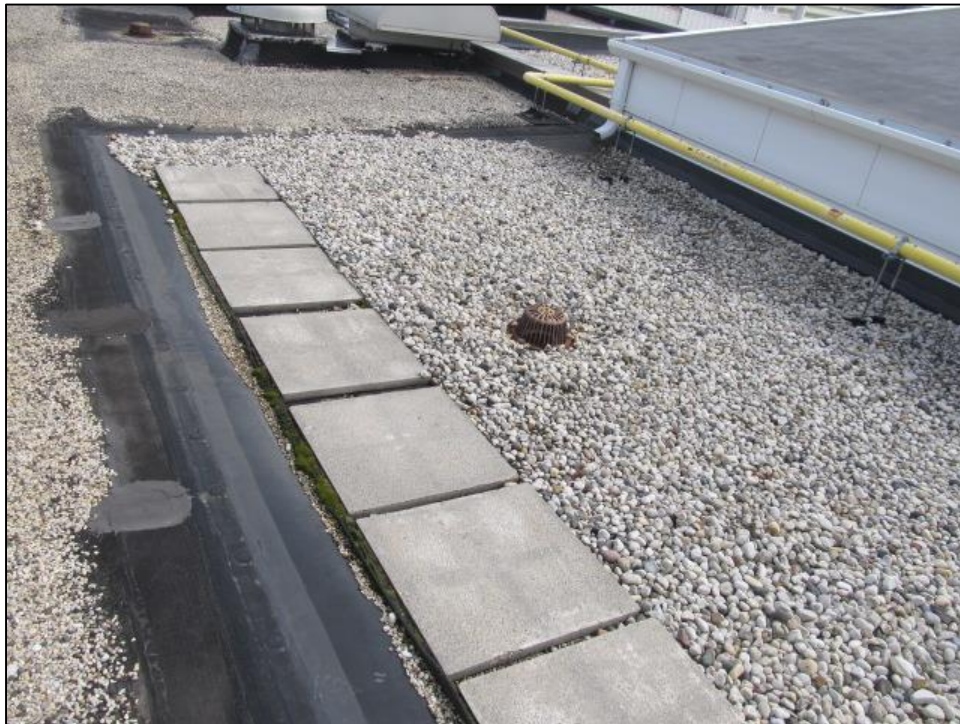
Roof Section	D-4
Estimated Age	11-14
Roof Area (SF)	280
Structural Deck	Concrete
Drainage	Roof Drain
Vapor Retarder	Yes-4 Ply Hot
Insulation	2 ½" Polyiso, 2 ½" Polyiso
R-Factor	27.5
Membrane	EPDM-Ballasted
Flashing	EPDM
Surfacing	Ballast
Estimated Roof Service Life	10+
Replacement Cost	\$3,200
Annual Maintenance Budget	\$250

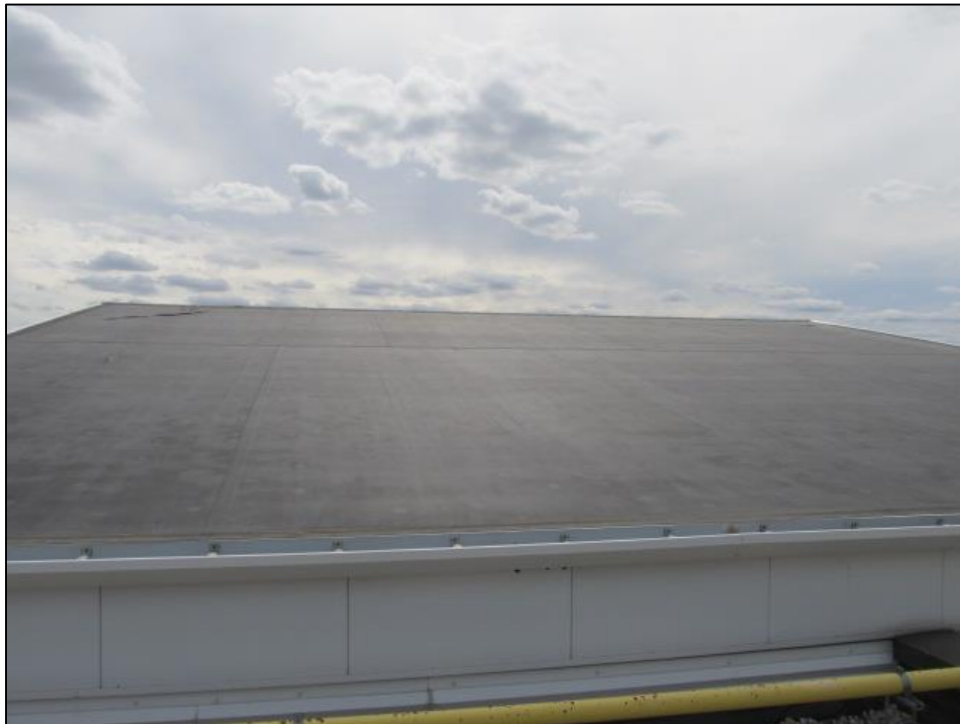
Roof Section	D-5
Estimated Age	11-14
Roof Area (SF)	1,470
Structural Deck	Metal
Drainage	Water Over Edge
Vapor Retarder	-
Insulation	1" Polyiso, 1" Hardboard
R-Factor	6.86
Membrane	EPDM-Fully Adhered
Flashing	-
Surfacing	-
Estimated Roof Service Life	10+
Replacement Cost	\$16,750
Annual Maintenance Budget	\$300

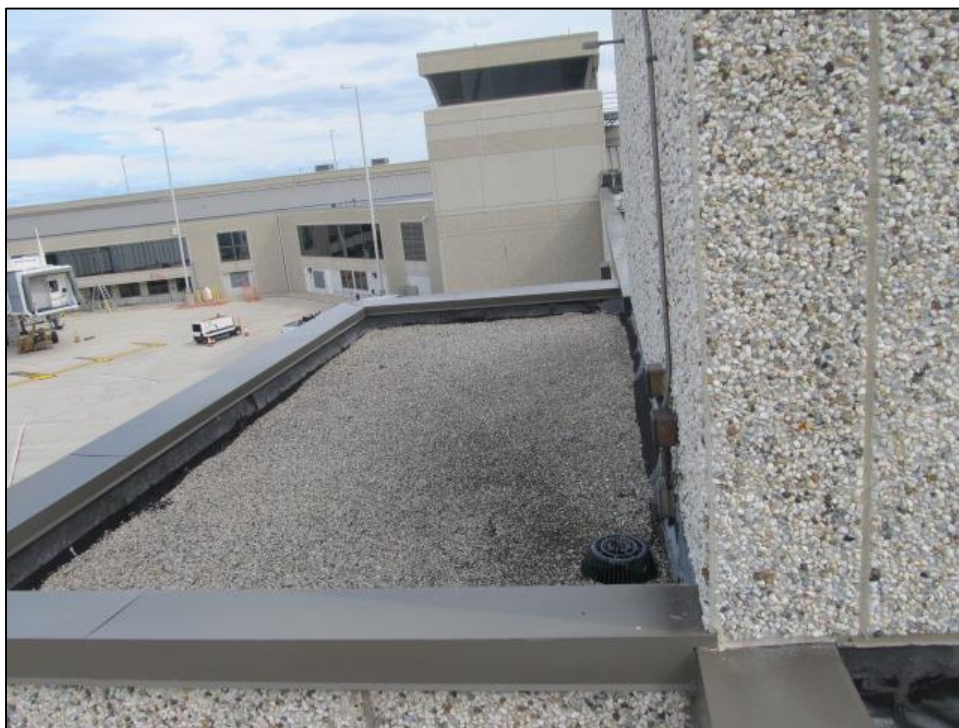
Roof Section	D-6
Estimated Age	24-29
Roof Area (SF)	265
Structural Deck	Concrete
Drainage	Roof Drain
Vapor Retarder	-
Insulation	4" Asphaltic Fill, 2 ½" Perlite
R-Factor	-
Membrane	Built-Up
Flashing	Smooth Surfaced Modified
Surfacing	Gravel
Estimated Roof Service Life	1-3
Replacement Cost	\$3,500
Annual Maintenance Budget	\$400

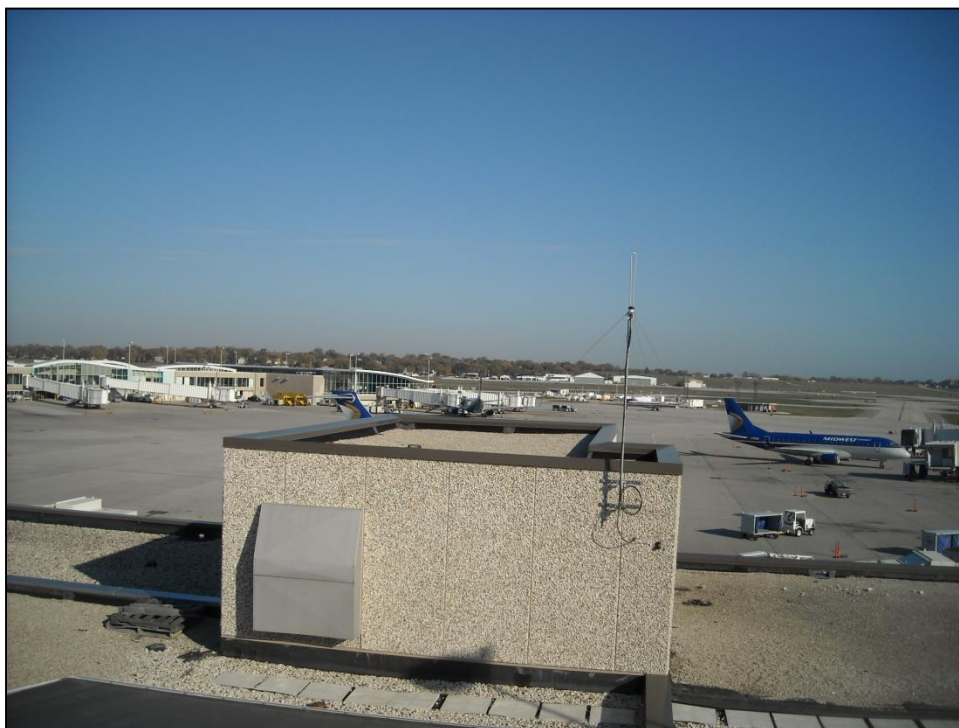
Roof Section	D-7
Estimated Age	24-29
Roof Area (SF)	606
Structural Deck	Metal
Drainage	Roof Drain
Vapor Retarder	-
Insulation	Asphaltic Fill, 2 Layers Perlite
R-Factor	18
Membrane	Built-Up
Flashing	Organic
Surfacing	Gravel
Estimated Roof Service Life	1-3
Replacement Cost	\$7,750
Annual Maintenance Budget	\$400

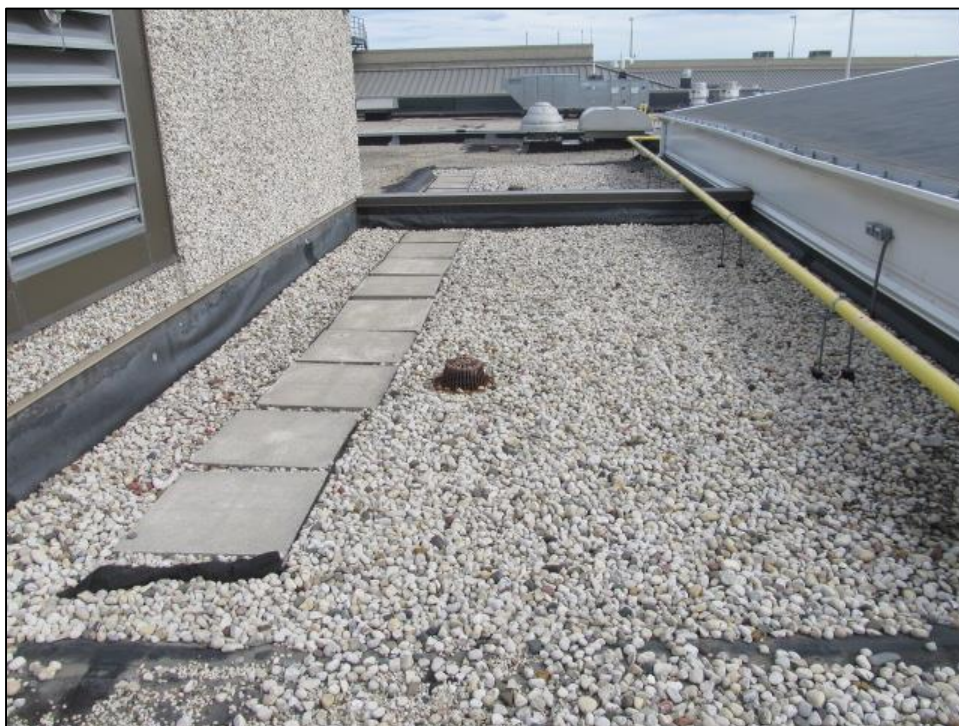
Roof Section	D-8
Estimated Age	11-14
Roof Area (SF)	308
Structural Deck	Concrete
Drainage	Roof Drains
Vapor Retarder	Yes
Insulation	3" Polyiso, ½" Hardboard
R-Factor	17.1
Membrane	EPDM-Ballasted
Flashing	EPDM
Surfacing	Ballast
Estimated Roof Service Life	10+
Replacement Cost	\$3,080
Annual Maintenance Budget	\$200

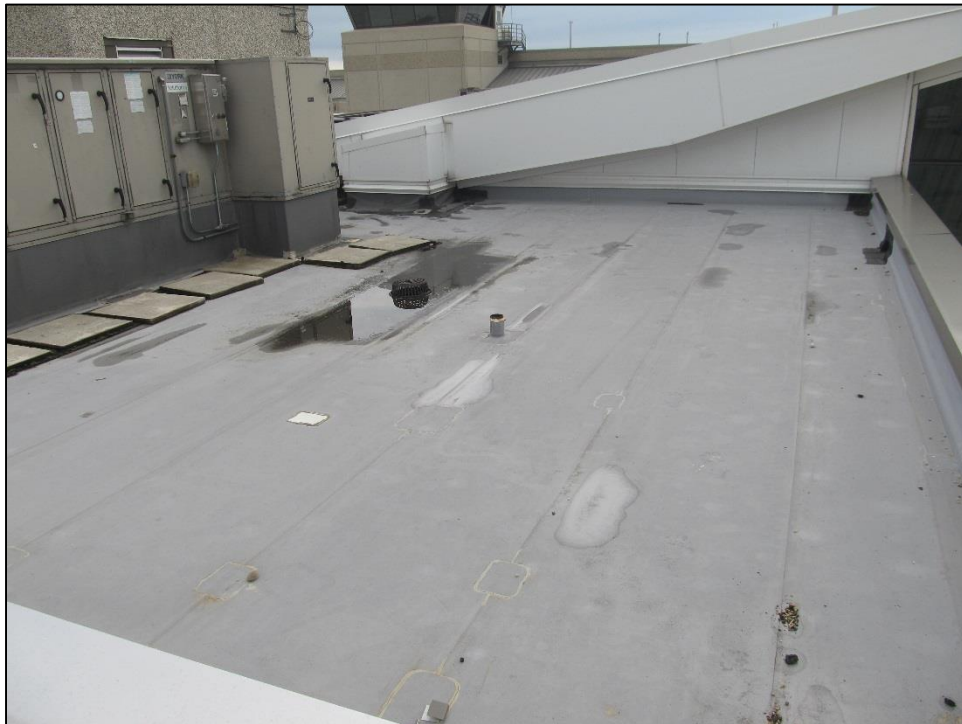
Roof Section	D-9
Estimated Age	24-29
Roof Area (SF)	780
Structural Deck	Concrete
Drainage	Roof Drains
Vapor Retarder	-
Insulation	1" Phenolic Foam, Tapered Perlite
R-Factor	Varies
Membrane	TPO-Mechanically Attached
Flashing	TPO
Surfacing	-
Estimated Roof Service Life	1-3
Replacement Cost	\$9,800
Annual Maintenance Budget	\$750

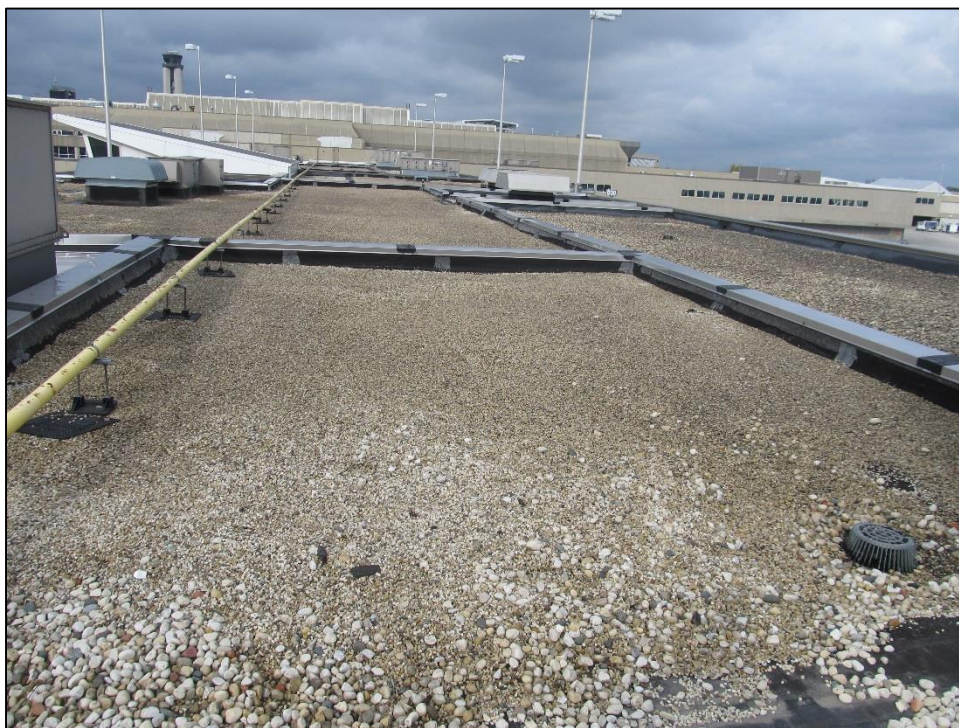
Roof Section	D-10
Estimated Age	24-29
Roof Area (SF)	600
Structural Deck	Concrete
Drainage	Roof Drains
Vapor Retarder	-
Insulation	3" Asphaltic Fill, 3" Perlite
R-Factor	
Membrane	Built-Up
Flashing	Smooth Surfaced Modified
Surfacing	Gravel
Estimated Roof Service Life	1-3
Replacement Cost	\$6,000
Annual Maintenance Budget	\$450

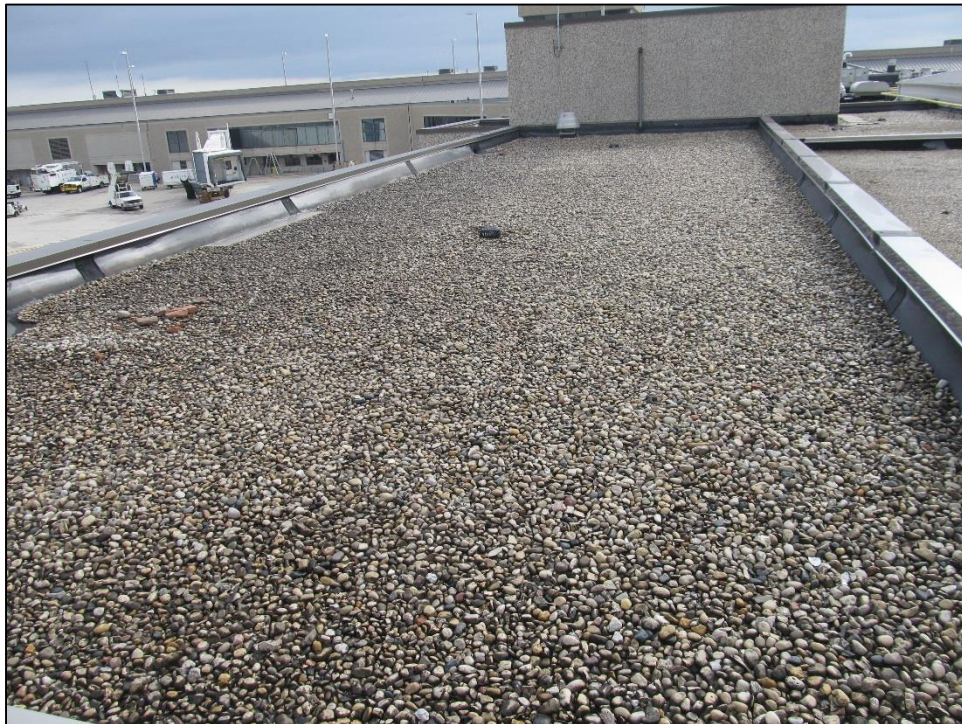
Roof Section	D-11
Estimated Age	24-29
Roof Area (SF)	2,054
Structural Deck	Concrete
Drainage	Roof Drains & Scuppers
Vapor Retarder	-
Insulation	Tapered Polyiso
R-Factor	Varies
Membrane	EPDM-Ballasted
Flashing	EPDM
Surfacing	Ballast
Estimated Roof Service Life	1-3
Replacement Cost	\$22,750
Annual Maintenance Budget	\$800

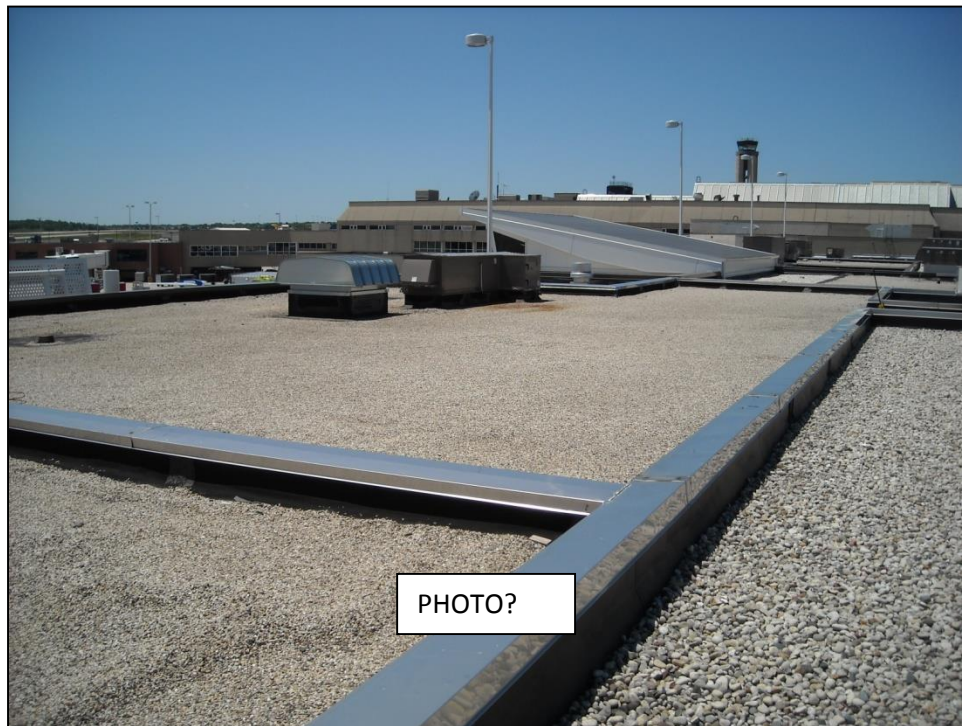
Roof Section	D-12
Estimated Age	24-29
Roof Area (SF)	3,200
Structural Deck	Concrete
Drainage	Roof Drains
Vapor Retarder	Yes
Insulation	Asphaltic Fill, Tapered Perlite
R-Factor	Varies
Membrane	Built-Up
Flashing	Smooth Surfaced Modified
Surfacing	Gravel
Estimated Roof Service Life	1-3
Replacement Cost	\$35,000
Annual Maintenance Budget	\$750

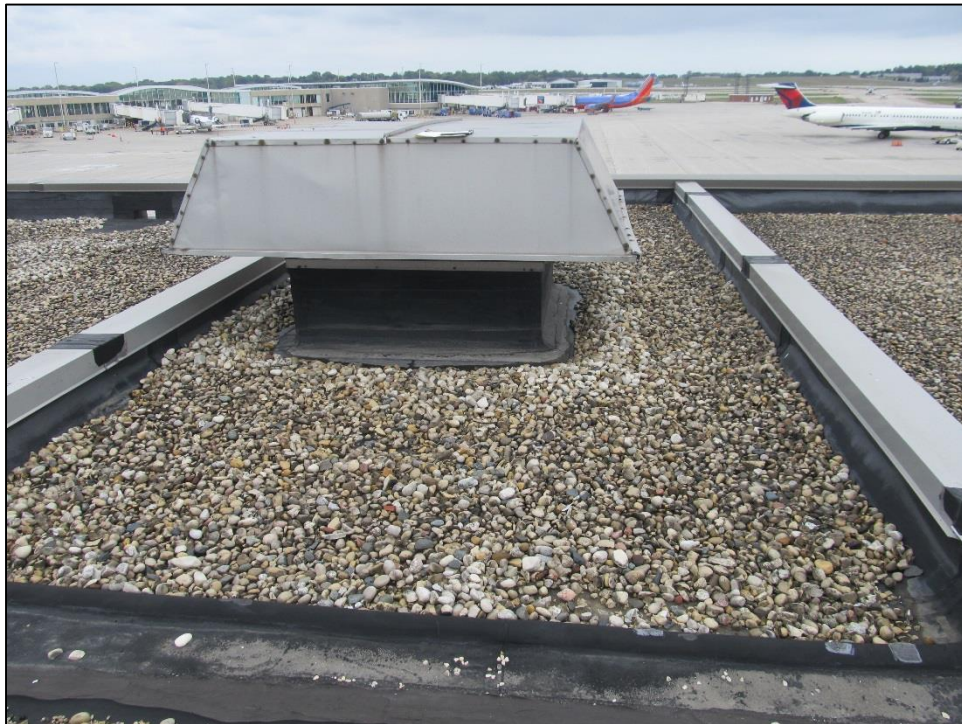
Roof Section	D-13
Estimated Age	24-29
Roof Area (SF)	286
Structural Deck	Concrete
Drainage	Roof Drains & Scupper
Vapor Retarder	-
Insulation	2" Polyiso
R-Factor	11
Membrane	EPDM-Ballasted
Flashing	EPDM
Surfacing	Ballast
Estimated Roof Service Life	1-3
Replacement Cost	\$3,750
Annual Maintenance Budget	\$400

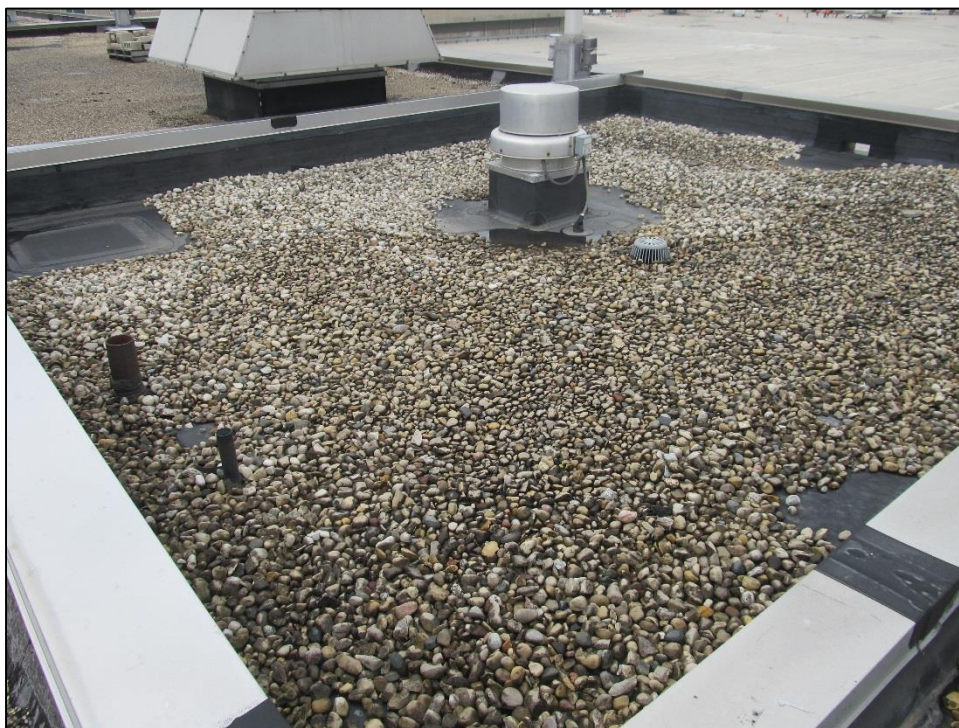
Roof Section	D-14
Estimated Age	24-29
Roof Area (SF)	546
Structural Deck	Metal
Drainage	Roof Drains
Vapor Retarder	-
Insulation	1" Perlite, Tapered Poly
R-Factor	Varies
Membrane	EPDM-Ballasted
Flashing	EPDM
Surfacing	Ballast
Estimated Roof Service Life	1-3
Replacement Cost	\$5,750
Annual Maintenance Budget	\$400

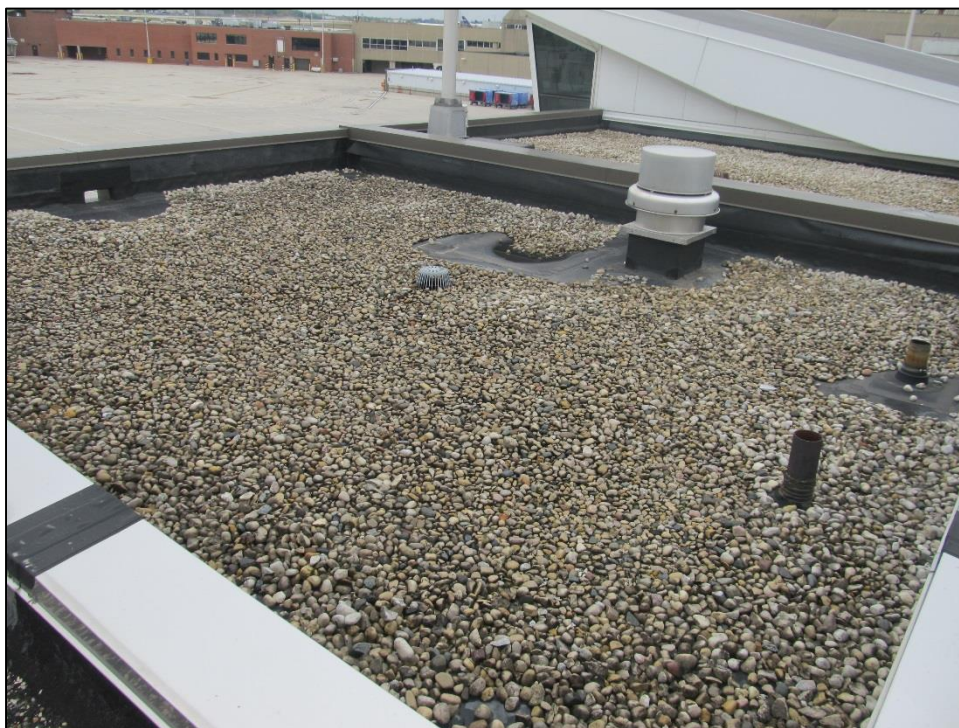
Roof Section	D-15
Estimated Age	24-29
Roof Area (SF)	520
Structural Deck	Metal
Drainage	Roof Drains & Scuppers
Vapor Retarder	-
Insulation	1" Perlite, Tapered Poly
R-Factor	Varies
Membrane	EPDM-Ballasted
Flashing	EPDM
Surfacing	Ballast
Estimated Roof Service Life	1-3
Replacement Cost	\$5,750
Annual Maintenance Budget	\$400

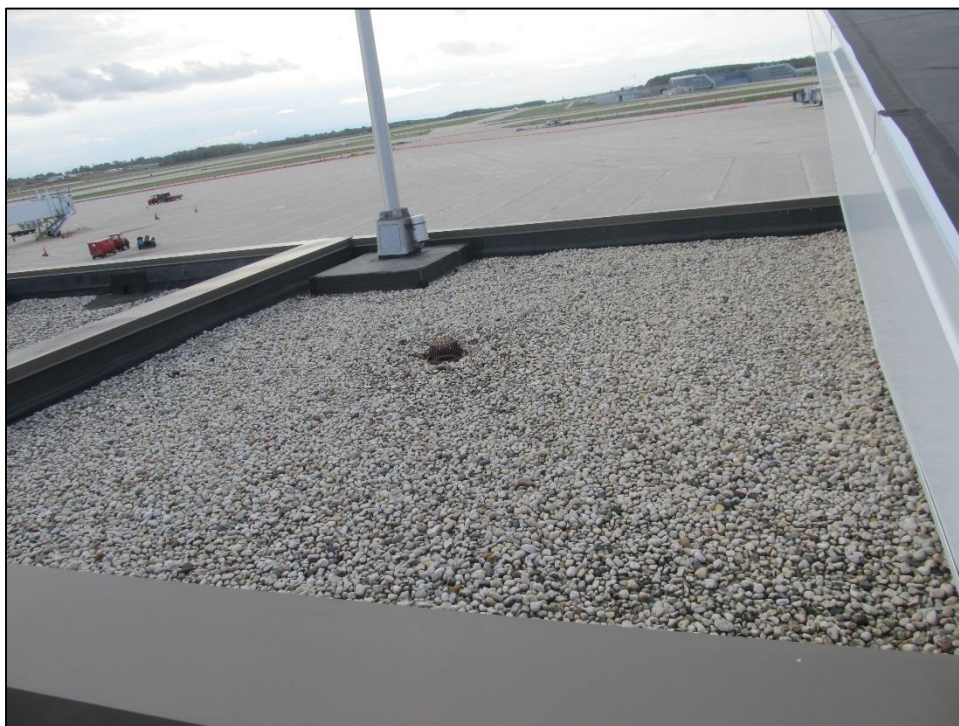
Roof Section	D-16
Estimated Age	11-14
Roof Area (SF)	545
Structural Deck	Concrete
Drainage	Roof Drains
Vapor Retarder	-
Insulation	2" Poly, 2" Poly
R-Factor	16
Membrane	EPDM-Ballasted
Flashing	EPDM
Surfacing	Ballast
Estimated Roof Service Life	10+
Replacement Cost	\$5,750
Annual Maintenance Budget	\$200

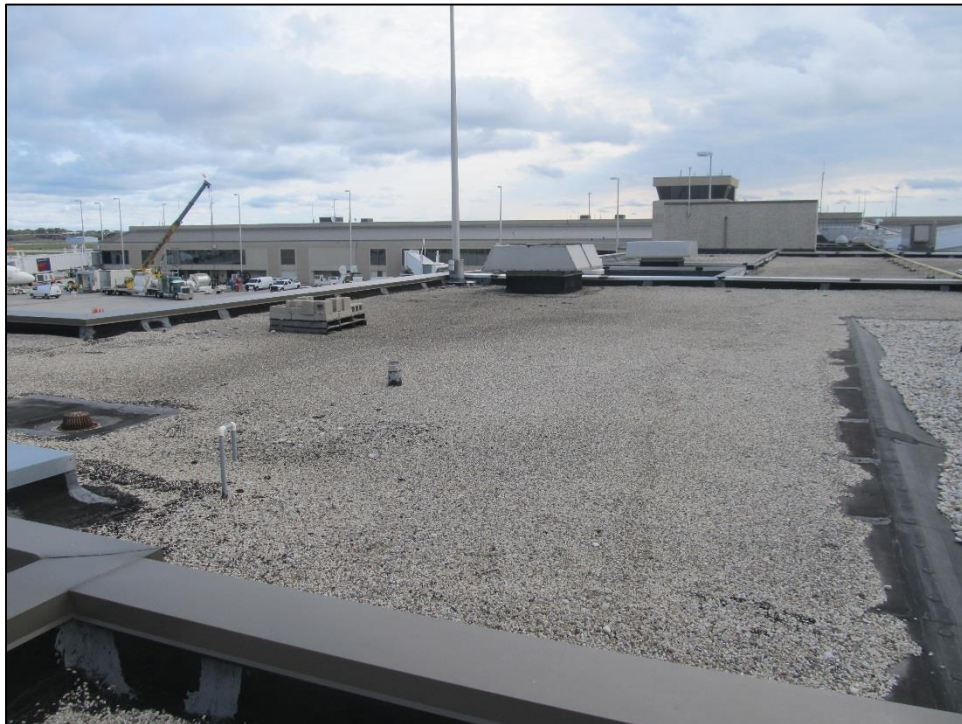
Roof Section	D-17
Estimated Age	24-29
Roof Area (SF)	2,600
Structural Deck	Concrete
Drainage	Roof Drains & Scuppers
Vapor Retarder	Yes
Insulation	Asphaltic Fill, Perlite
R-Factor	Varies
Membrane	Built-Up
Flashing	Smooth Surfaced Modified
Surfacing	Gravel
Estimated Roof Service Life	1-3
Replacement Cost	\$28,000
Annual Maintenance Budget	\$600

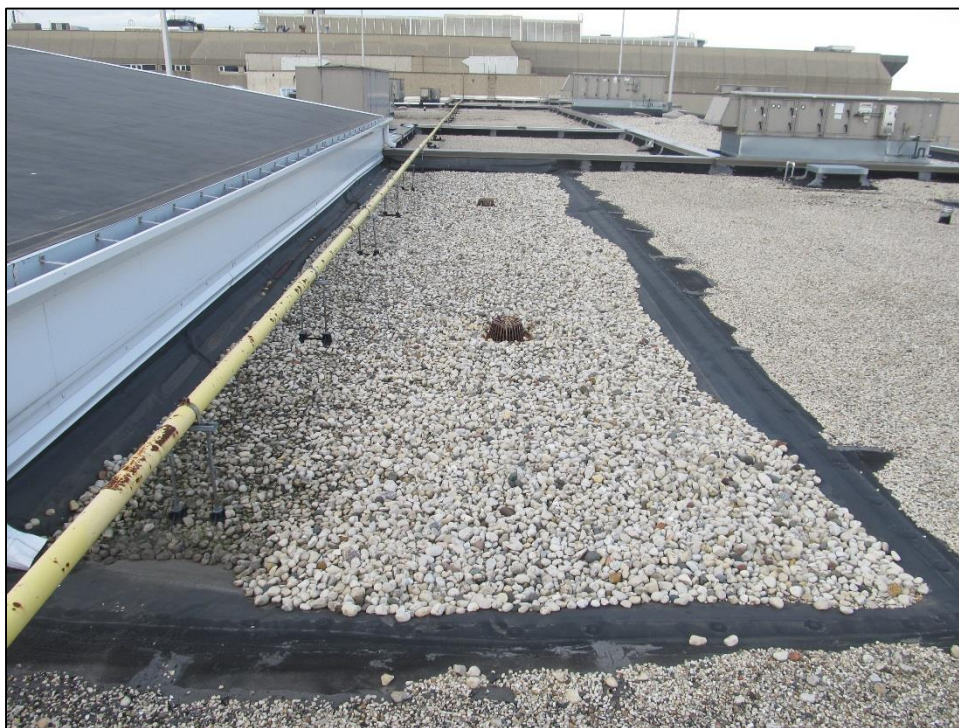
Roof Section	D-18
Estimated Age	11-14
Roof Area (SF)	420
Structural Deck	Concrete
Drainage	Roof Drains
Vapor Retarder	Yes
Insulation	3" Polyiso, ½" Hardboard
R-Factor	17.1
Membrane	EPDM-Ballasted
Flashing	EPDM
Surfacing	Ballast
Estimated Roof Service Life	10+
Replacement Cost	\$4,750
Annual Maintenance Budget	\$275

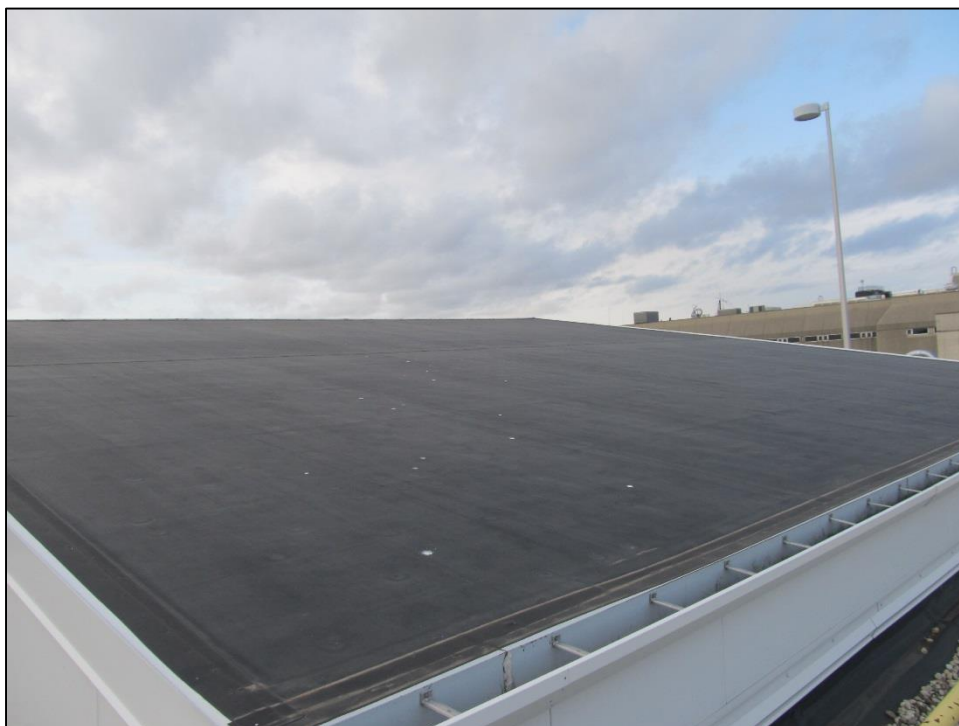
Roof Section	D-19
Estimated Age	11-14
Roof Area (SF)	1,470
Structural Deck	Metal
Drainage	Water Over Edge
Vapor Retarder	-
Insulation	1" Polyiso, 1" Hardboard
R-Factor	6.86
Membrane	EPDM-Fully Adhered
Flashing	-
Surfacing	-
Estimated Roof Service Life	10+
Replacement Cost	\$15,750
Annual Maintenance Budget	\$275
